SEASTAR™
BAYSTAR™

INCREASED TORQUE VALUE FOR POSITIONAL O-RING FITTINGS

Installed on NEW –3 model steering cylinders

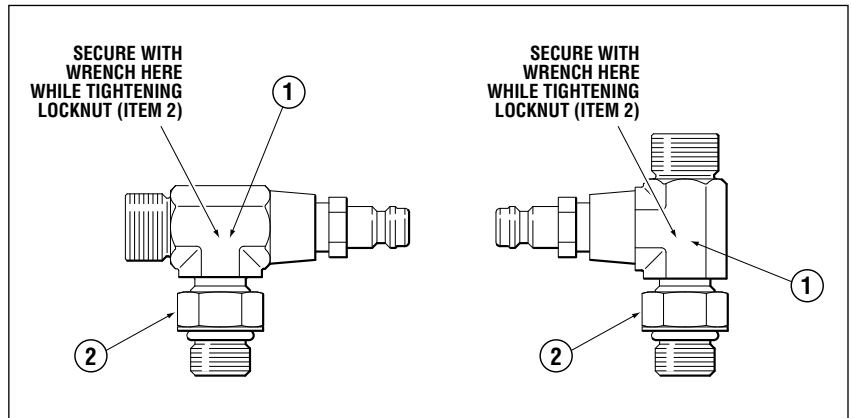
Figure A.

SeaStar Solutions has increased the torque setting of the 'Positional O-ring hose fittings' which are installed in the new –3 steering cylinders. We have found that installations where hoses are; pulling on the fittings during operation, or in an area where they can be stepped on or kinked, over time may lead to loosening of the hose fitting resulting in loss of steering fluid. See list showing the cylinders affected.

Failure to properly tighten the locknut (item 2) may lead to loss of steering control. Loss of steering control may result in unpredictable boat behavior, collision with an obstacle and/or ejection from vessel, leading to property damage, personal injury and/or death.

While holding fitting body (item 1) with a wrench, tighten the locknut (item 2) and torque to 40–43 ft-lb.
