SEASTAR POWER STEERING CROSS-OVER RELIEF VALVE Part# HP5822

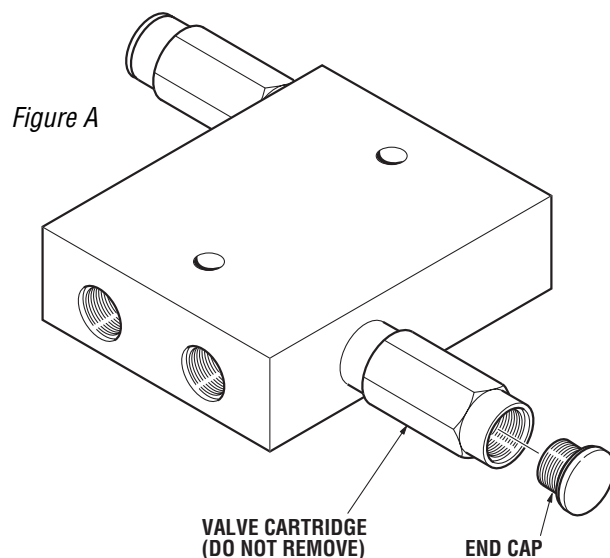
We have recently been advised of a few isolated incidents where the SeaStar Cross Over Relief valve (part # HP5822) relief pressure may have been set incorrectly. This could potentially cause partial steering articulation i.e. rudder may not move its full distance, resulting in a larger turning radius. Teleflex feels it prudent that vessels built in January 2003 through June 2004 with the HP5822 valve pressure verified and set to the appropriate level (1200 psi).

1. Remove the end cap using a suitable set of pliers or vice grips. Refer to Figure A. **DO NOT** remove entire cartridge valve.
2. Using a 1/4" Allen key, turn the adjusting screw clockwise until it bottoms out while counting the number of turns. Refer to Figure B.

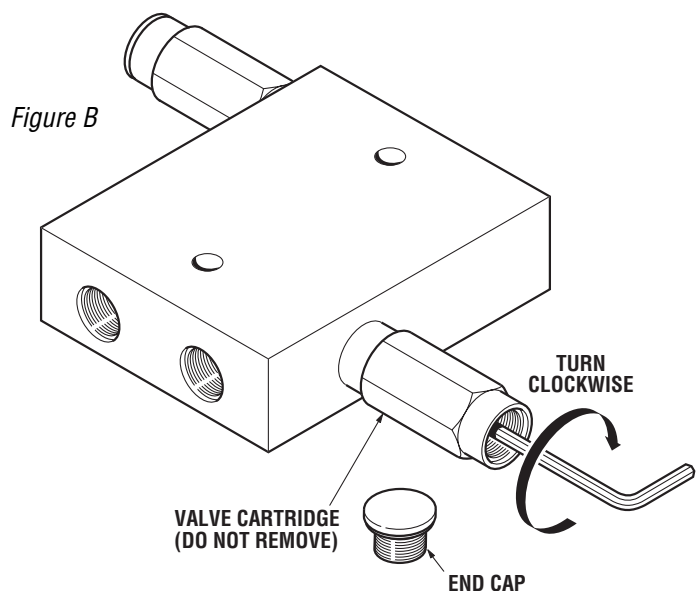
NOTICE If it took more than 3.5 turns to bottom out the adjuster, the factory setting was most likely incorrect. For example: at 7 turns, the pressure setting was approximately 600 psi.

3. After bottoming out the screw, back the adjusting screw out 3.5 turns. Valve is now set to correct pressure of ~1200 psi.
