# OUTBOARD PIVOT MOUNT CYLINDER(S) EQUIPPED WITH SEASTAR POWER ASSIST STEERING

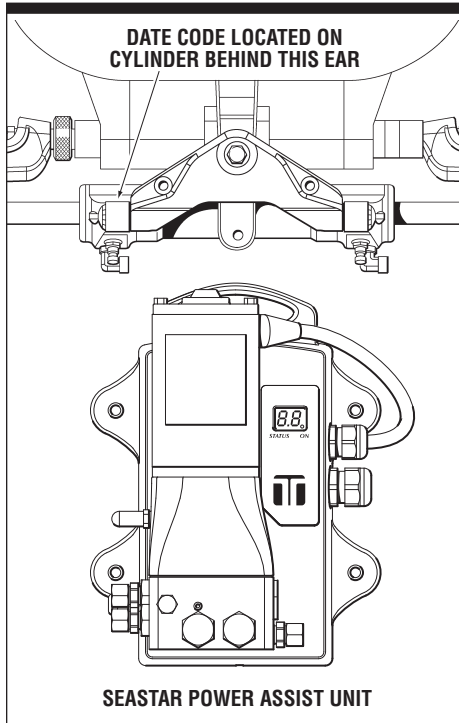
Figure A.

Teleflex Marine has been made aware of a few isolated cases where the SeaStar Power Assist has caused the end glands used on SeaStar Front Mount Pivot Cylinders to loosen, resulting in loss of steering fluid causing reduced steering control; which may result in property damage and/or personal injury.

- If you have a SeaStar Power Assist (refer to Figure A) **with** an outboard steering cylinder listed in table 2 **with** a date code falling in table 1, you need to adhere to the tightening instructions listed on page 2 of this advisory.
- If your boat does **NOT** have a Power Assist, **AND/OR** your outboard cylinder does **NOT** fall within those listed in Table 1, **NO action is required.**

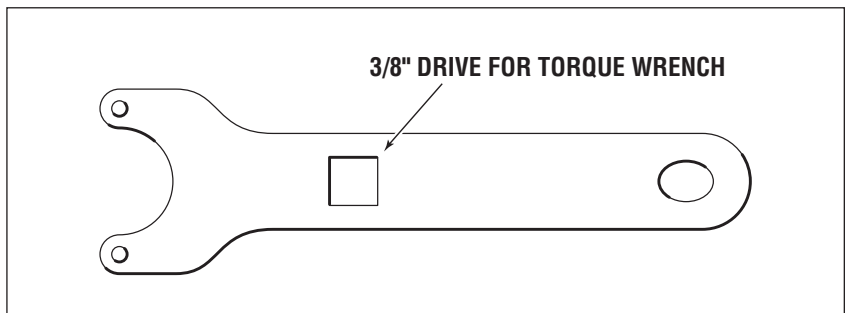
Figure C. Fixed spanner wrench shown.

*Any adjustable or fixed spanner wrench with a 3/8" drive for a torque wrench can be used. If you do not have a spanner wrench please contact Teleflex and one will be shipped to you immediately.*
