Teleflex® INSTALLATION ADVISORY NOTICE

Copy Part# 810028, Rev. C

INSTALLATION OF SEASTAR VENT & NON-VENT HELM PUMP FILLER PLUGS

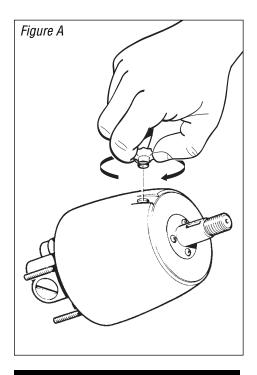
Teleflex Canada has learned of a few isolated cases where the internal pressure relief on SeaStar filler plugs has been damaged causing the helm to leak fluid. Please read the following installation procedure to ensure that your system is operating properly.

When installing both vent, and non-vent plugs, tighten **finger tight** 5in-lbs (0.58 Nm) MAX. <u>DO NOT</u> use wrenches or pliers.

If you feel that your plug(s) have damage from being over tightened, contact Teleflex Canada and a new plug will be sent to you.

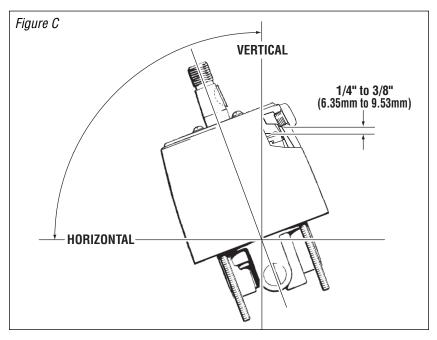
Ensure your hydraulic fluid level is set to the correct level to avoid vent plug leaks and retain optimal performance of your SeaStar Steering system.

The oil level should be set at approximately 1/4" (6.35mm) to 3/8" (9.53mm) below the filler port threads. A small air pocket is required, as the oil will expand with heat.

TIP: Fill oil to the top of the filler port and use HA5403 Kit (purchased separately) to extract oil to the position marked on the tube, 1cu in. This will set your oil to the correct level.
