# INSTALLATION OF SEASTAR CYLINDER HC5331 CABLE TUBE SUPPORT KIT# 785255

Teleflex Canada has learned of a few isolated cases where the cable tube has cracked on the Volvo Power Steering drives, SX, DP-S and XDP, causing loss of steering control. Please read the following inspection and installation procedures to ensure your system is operating properly.

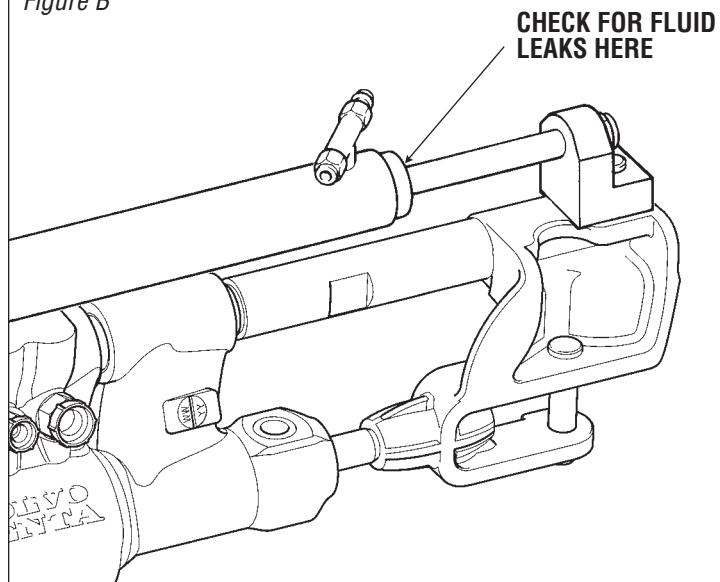
Figure B

During inspection also check for signs of hydraulic fluid leaking in the area noted in figure B.
