SEASTAR/BAYSTAR NYLON TUBING LOT# 71335 AND 71336

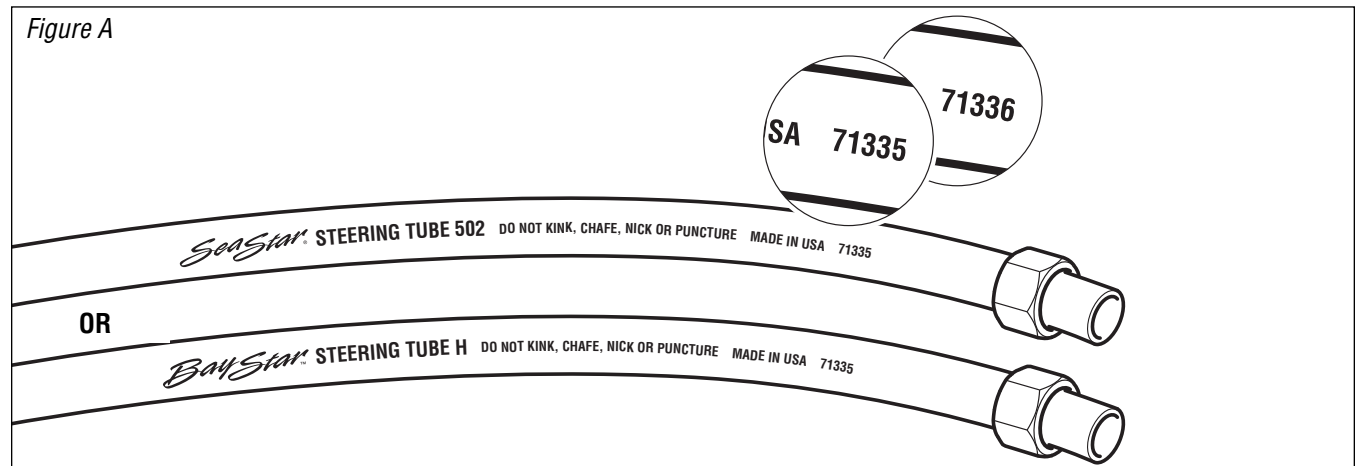
Through in-house testing Teleflex Canada has found an isolated failure with our SeaStar/Baystar Nylon Tubing, Lot# **71335/71336**. This may result in loss of steering causing property damage and/or personal injury. Please read the following inspection procedure and ensure you follow **ALL** instructions prior to your boats next use.

Locate the 'lot number' on the SeaStar/Baystar Nylon Tubing. (Refer to figure A.) Check **ALL** tubing on board your boat for this Lot number. If your tubing is **NOT** marked Lot# '**71335**' or '**71336**', or is marked with a different number, please go to Step 3.

If any of your boats tubing is marked with Lot# '**71335**' or '**71336**' (refer to figure A), this tubing must be removed and replaced prior to your boats next use. Please contact our **Warranty Department toll free at 1-866-779-6899** for replacement parts.
