# HYDRAULIC STEERING BLEEDER NUT DEFECTS

Through in house testing, Teleflex Marine has found an isolated failure of Bleeder Nut part # 794926, where it has cracked due to stress corrosion. All Bleeder Nuts that have been assembled with SeaStar or BayStar Cylinders, SeaStar Power Assist Pumps or supplied in SeaStar/BayStar/Hynautic Fitting kits between **March 1st, 2007 and June 30th, 2007** **MUST** be replaced prior to the next use of the vessel. Although very few of these Bleeder Nuts may have been shipped, and the likelihood of a nut cracking during use is extremely remote, Teleflex Marine feels it is prudent to replace ALL Bleeder Nuts immediately.

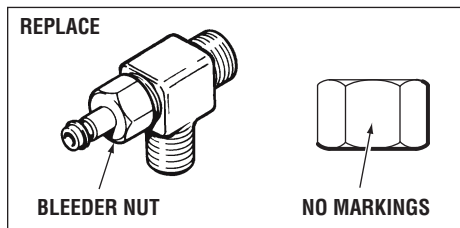
Figure 1a

The Bleeder Nuts shown in Figure 1b have specific “Head Markings” that are stamped directly on the fitting and DO NOT need to be replaced. These marks identify the location of where the nut was manufactured. **ONLY** Bleeder Nuts that have **NO** markings will need to be replaced (refer to Figure 1a).

After confirming that the cylinder(s), Power Assist pump(s) and/or Fitting kits fall within the date code and/or serial numbers noted and has bleed nuts **WITHOUT** "Head Markings" as shown on page 1, contact Teleflex Marine at the number listed below to arrange for immediate shipment of new Bleeder Nuts directly to you. Once the new Bleeder Nuts are received there will be no need to return the defective nuts to us. The defective bleeder nuts must be scrapped to prevent these from being used in any other application

When installing new Bleeder Nuts, torque to 85 in. lb. MAX.

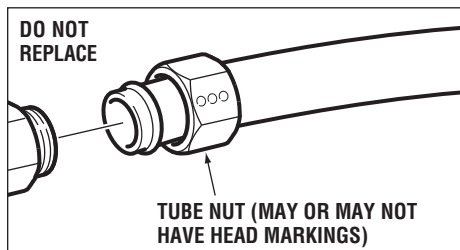
Figure 1c

The following figures show the location of the “BLEEDER NUT” in relation to the unit it is installed on. We would like to stress that although similar in appearance, the “TUBE NUT” used to crimp SeaStar and BayStar Nylon Tubing onto a helm and/or cylinder (refer to Figure 1c), is NOT affected. To avoid unnecessary time and labor, ENSURE that ONLY the Bleeder Nut is replaced. Page 3 of this Advisory Notice has a complete list of all affected part numbers.

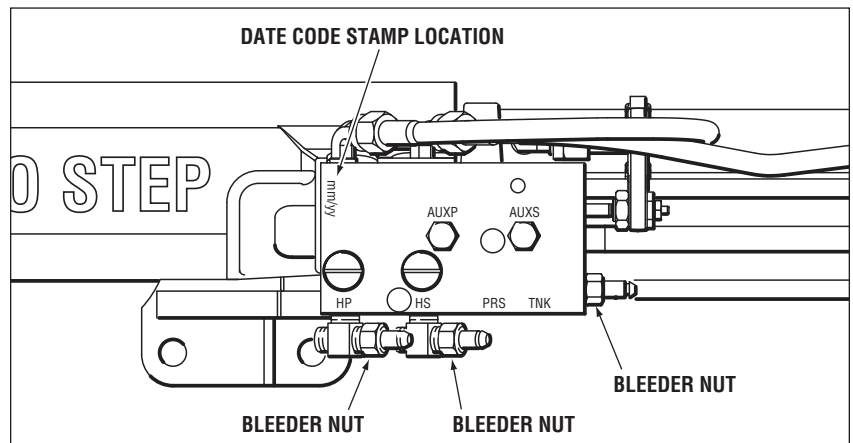
Figure A: Power Steering Cylinder

ALL Power Steering Cylinder will have 3 (three) Bleeder Nuts that may need to be replaced as per the markings listed above. A complete list of part numbers affected can be found on page 3 of this notice.

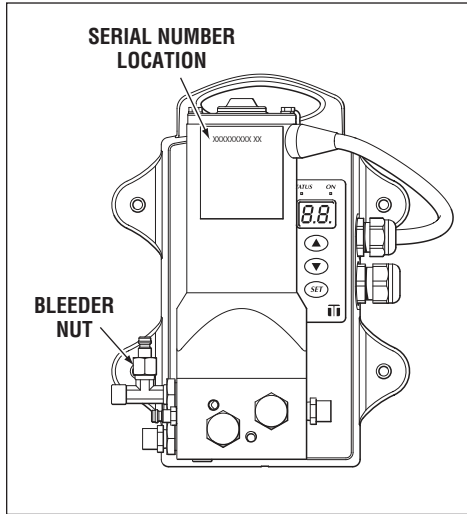
**Figure B: Power Assist Pump**

ALL Power Assist Pumps may have 1 (one) Bleeder Nut that will need to be replaced as per the markings on page 1 of this notice. A list of serial numbers of affected Power Assist Pumps can be found on page 3 of this notice.

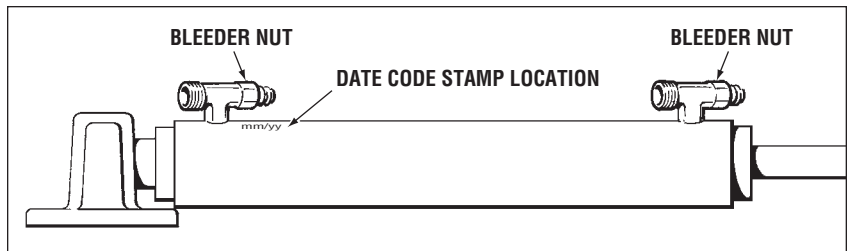
**Figure E: SeaStar Inboard Steering Cylinder**

ALL Manual Steering Cylinders may need to have 2 (two) Bleeder Nuts replaced as per the markings on page 1 of this notice. A complete list of part numbers affected can be found on page 3 of this notice.
