# SEASTAR STEERING POWER ASSIST PUMPS

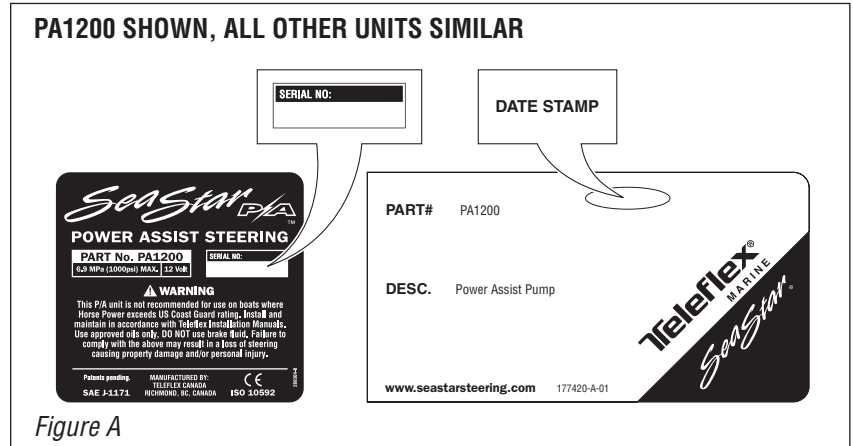
- Using Figure A. Locate the date stamp on the Blue and White label affixed to the outside of the Power Assist package.
- If the date stamp noted on the package falls between February 15th, 2007 through April 4th, 2007 then please continue onto the Warranty Procedures noted below.
- If the date stamp noted on the package does **NOT** fall between February 15th, 2007 through April 4th, 2007 then no action is required.

- Using Figure A above. Locate the serial number on the decal that is affixed directly to the Power Assist Pump.
- if the serial code number falls between 01-018100 and 01-018500 then please continue onto the Warranty Procedure noted below.

- 1 Confirm that the unit falls within the date stamps noted above and/or you have had problems arise within 24 hours of the system being installed.
- 2 Contact Teleflex Marine Warranty Department at 866-779-6899 to obtain an RGA # (Returned Goods Authorization #).
