BULLETIN

TO: ALL AFTERMARKET CUSTOMERS
FROM: JIM LOMBARDI – PRODUCT MANAGER
DATE: MAY 28, 2014
SUBJECT: EMERGENCY CUT-OFF SWITCH

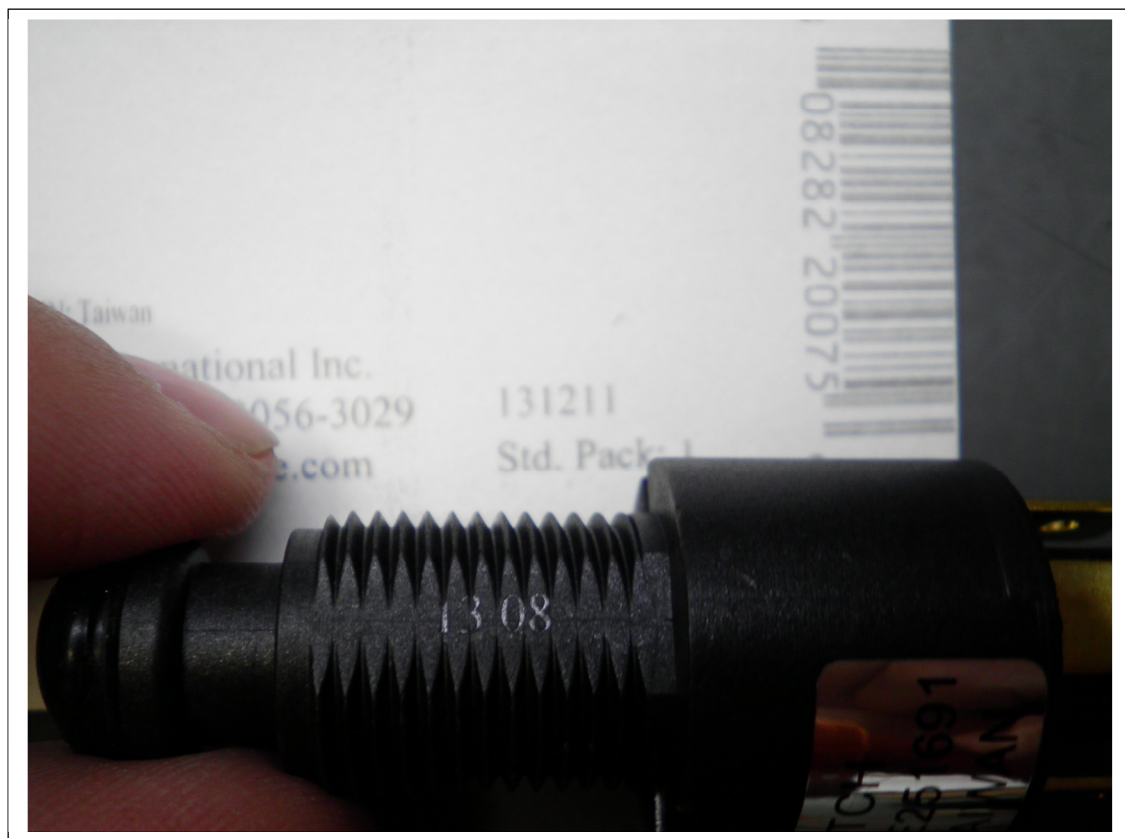
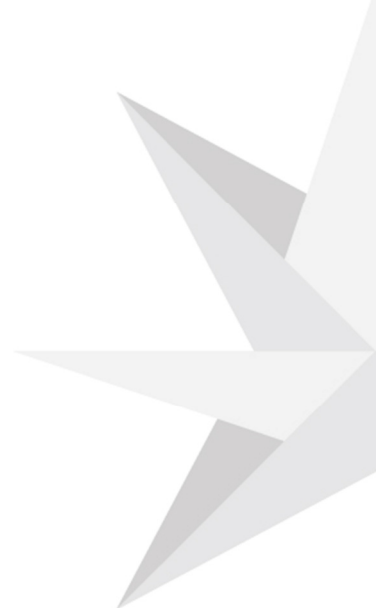
The above listed switches are marked on the shaft flat with one of the following numbers 1305, 1308 (See picture below). Only a limited number of these switches were improperly assembled. Please advise customers, who have purchased the above part numbers to perform the following test to determine if they have an improperly assembled switch:

1. Push and release the plunger 10 times
2. Pull up on the plunger 3 times
3. Push and release the plunger 10 more times
4. Pull up on the plunger 3 more times
5. If the plunger does not remove from the switch it is properly assembled.

If your customer is in possession of an improperly assembled switch, please have them contact our warranty department for warranty replacement information. Please contact our technical services department at the number below to obtain an RGA for any affected switches in stock.
