SMARTCYLINDER CONNECTION TO PCM

SeaStar Solutions has recently been made aware of a few isolated cases where the steering can experience a sensor fault which may cause steering disruption (loss of steering response).

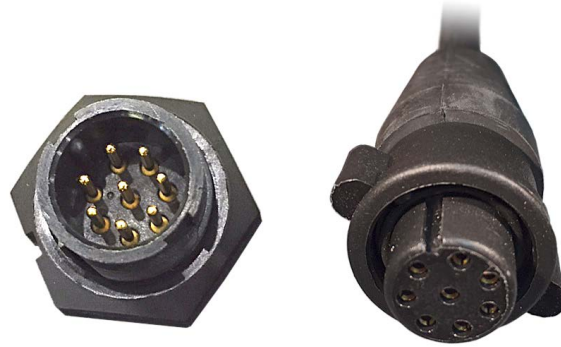
Figure A. No Corrosion

NO CORROSION

- No evidence of contamination

2. For multi engine applications, repeat process for Starboard side.
3. If no evidence of corrosion is found on any of the connectors (see figure A), proceed to step #5.

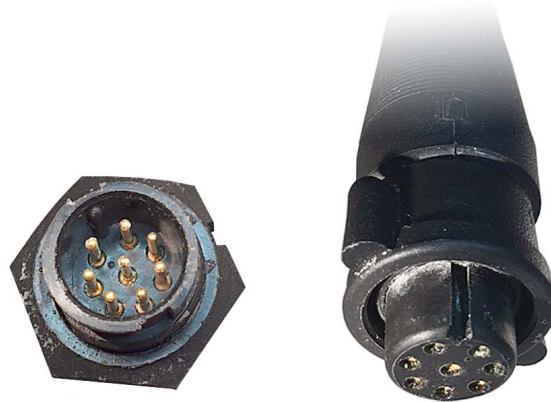
Figure B. Minor Corrosion

MINOR CORROSION

- Thin layer of contamination on male pins
- Minor evidence of green or grey oxidization on female pins

4. If corrosion is found, identify the amount of corrosion in the connector
 - a. Minor corrosion (see figure B) can be cleaned with electrical contact cleaner and a bristled brush, then proceed to Containment Practices.

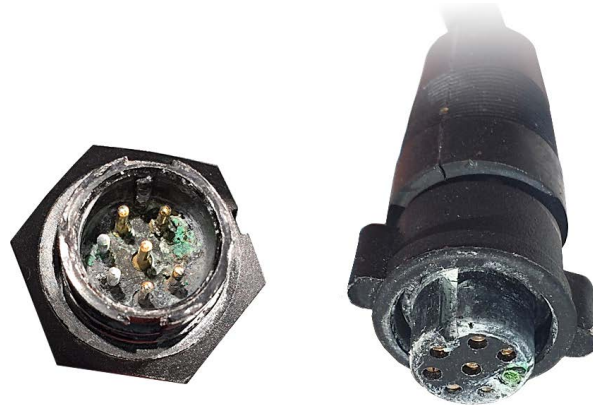
Figure C. Significant Corrosion

Significant corrosion within any of the SmartCylinder connections may lead to loss of steering control causing property damage and/or personal injury or death.

SIGNIFICANT CORROSION

- Broken pin(s)
- Green or grey oxidization around male pins
- Visible corrosion inside female pins

- b. Significant corrosion (see figure C). If the male pins on the PCM's RFU connector are badly pitted or severely oxidized to a greenish color, have your dealer contact SeaStar Solutions for further evaluation.

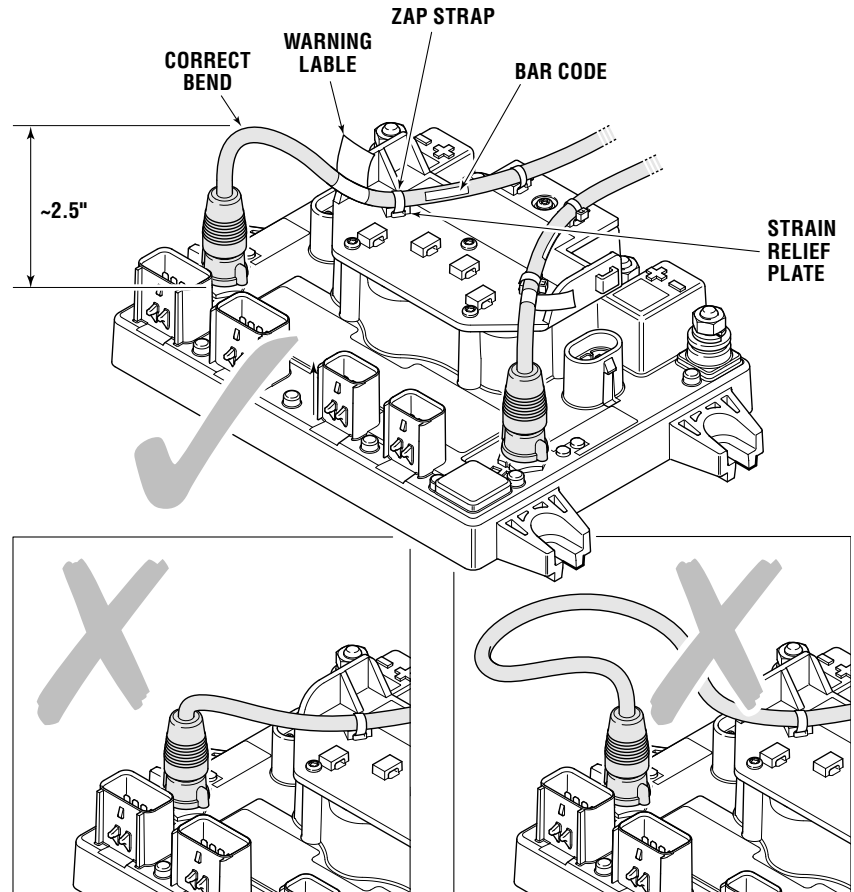
Figure F.

These isolated incidents have been traced to water ingress of the SmartCylinder connection to the PCM (Pump Control Module) in moderately damp locations and can occur if the RFU (Rudder Feedback Unit) harness is strain relieved in a manner that disrupts the connector's seal. In the event this occurs, the Optimus EPS system will automatically detect this and notify the user via the CANtrak display and audible buzzer.

The RFU harness should be strain relieved in a manner that does not compromise the seal of the connector. The harness should extend vertically by approximately 2.5" from the base of the connector to the tallest point on the cable. Furthermore, the harness should be secured to the strain relief plate such that the primary zap strap is located between the warning and barcode labels on the harness. This configuration is shown in figure F.
