## SEASTAR™ TIEBAR KIT

### NOTICE

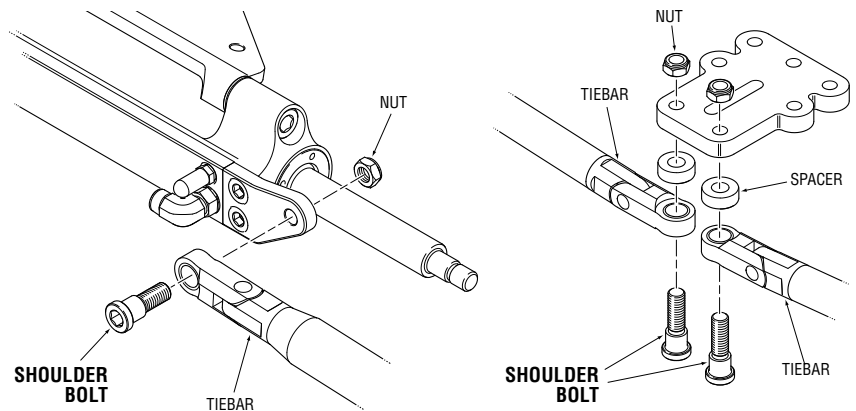
Figure A.

SeaStar Solutions have become aware of a part quality issue in a small number of tiebar kits where the shoulder bolt grade of stainless steel does not meet our specifications. The potentially affected shoulder bolts were shipped to customers between May 2, 2018 and June 15, 2018. Please verify that the material in your kit is correct as per the steps outlined below. Shoulder bolts with non-conforming material will not be an immediate risk to end users, however it is recommended that they be replaced if the deficiency is identified.

- Only the kits listed above, shown in the configuration below, and shipped between May 2, 2018 — June 15, 2018 are affected.
- Use a magnet to touch the head of shoulder bolt (*refer to part(s) identified in figure A*);
  - the correct material of the shoulder bolts will be strongly attracted to the magnet,
  - the incorrect material will show very weak or no magnetism.

*The shoulder bolts in your tiebar should be checked per the instructions below; if non-conforming material is detected in shoulder bolts on your tiebar, the shoulder bolts should be replaced.*

For free replacement bolts when incorrect material on your tiebar is detected: [Marine.Warranty@seastarsolutions.com](mailto:Marine.Warranty@seastarsolutions.com)
