**To:** Dometic Steering Cable Customers  
**From:** David Wolfe – Product Manager  
**Date:** August 2022  
**Subject:** Steering Cable Retaining Nut Campaign Notice

The attached Advisory Notice (AN2022005) concerns our Dometic SeaStar Steering Cables, and details how to identify if your Steering System uses a cable within the specific range of affected production cables.

## Dometic Steering Cable

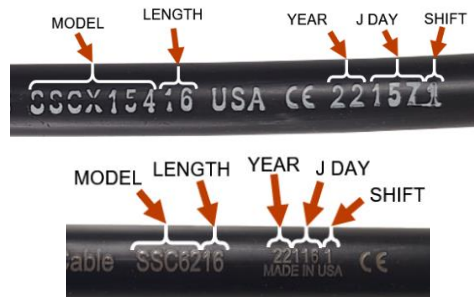
Cables are either heat stamped, or laser marked with their product information at the engine end of the cable.

Affected products are within:

**YEAR "22"**

and between  
**DAY** range:

**116 through 231**

Cables identified within this date range must be physically inspected as per the following **Step 3** and **Step 4** or **5**.

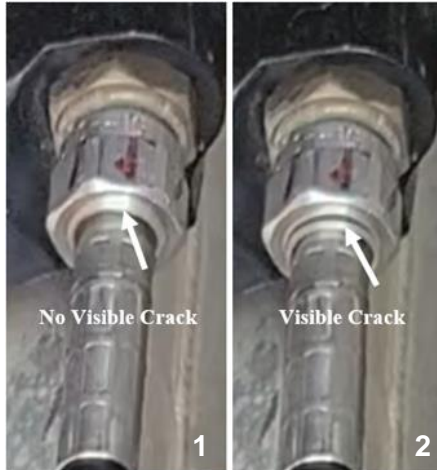
- b) On an installed, Fully Tightened nut, the first indication of a defect is a visible crack on the nut shoulder, as shown in **Photo 2**.

NOTE: Any evidence of a visible crack, as shown in **Photo 2**, around the shoulder is a failure. Proceed to **Step 6**.

If any of the inspection procedures above identifies a defective cable, you may either:

- a) contact Dometic  
email: [Lit-tech\\_web@dometic.com](mailto:Lit-tech_web@dometic.com)  
Phone: (877) 663-8396 Option 1

Dometic will provide an **RGA** (Return Goods Authorization) to exchange your cable.

- b) contact your nearest dealer for an appointment to have your cable inspected and, if defective, replaced at no cost to you.

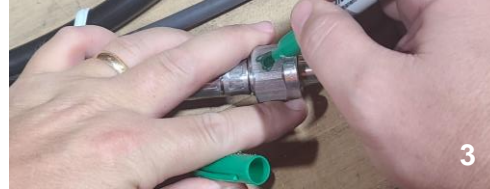
- a) If your cable has been marked on the retaining nut with a green dot shown below in **Photo 3**, the cable has been inspected by the factory and is not defective.

No further action is required on your part.

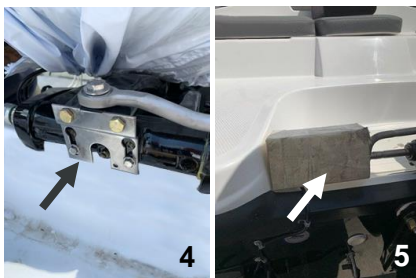
- c) With an installed cable and Fully Tightened nut, the initial fitting gap is less than 1/8 inch (0.125") as shown in **Photo 6**. This is also the case for a non-defective cable.

- f) When a Fully Tightened and **Defective** nut is present, any of the following can occur and indicates a failure:
- i. The gap shown in **Photo 7** is larger than 1/8 inch (0.125"),

- ii. The gap shown in **Photo 7** changes length by more than 1/16 inch (0.063"),
  - iii. Any formation of a visible crack as shown in **Step 3, Photo 2**,

- iv. Separation of the cable from the nut.

- a) If available, use the shipping brace that comes with your motor to immobilize the motor from turning as shown in **Photo 4**.
- b) If the shipping brace is not available, or your motor does not incorporate this feature, block starboard steering by preventing the output ram and drag link from extending, as shown in **Photo 5**.

- d) Have an observer watch the conduit fitting and retaining nut gap.
- e) With the motor locked from **Step 4** part **a)** or **b)**, apply 20 lbf-ft steering wheel torque in a Starboard (Right) turn.

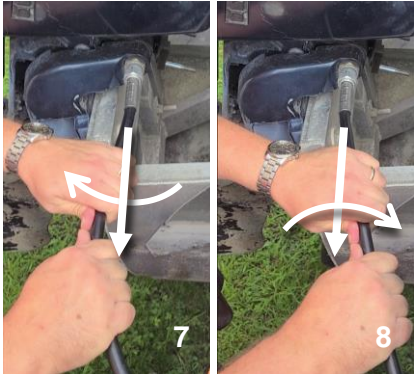
- d) Repeat up to 10 cycles.
- e) On a defective cable, the steel conduit fitting will move significantly with the cranking motion, and the nut shoulder will form a visible crack as shown in **Step 3, Photo 2**, or may sever completely allowing the cable to release from the nut.
- f) If any of the steps above result in failure, your inspection is complete. Proceed to **Step 6**.

NOTE: On a non-defective cable, the fitting will hold very firm, and no visible crack will form. Your cable is not defective, and no other action is required on your part.

- a) Ensure the retaining nut is Fully Tightened.
- b) Grasp the suspect conduit firmly with both hands approximately 4 inches from the end of the conduit fitting as shown in **Photo 7**.
- c) Rotate around the cable and Pull outward away from the retaining nut as shown in **Photos 7 and 8**.

NOTE: This is not a twisting motion similar to a screw driver, but is a cranking motion.
