To: Boat Owner
From: Aldo Mastropieri – Product Manager
Date: February 2020
Subject: SeaStar Hydraulic Hose Campaign Notice

Hydraulic Hose Campaign

U.S.C.G. campaign number 20SD0002.

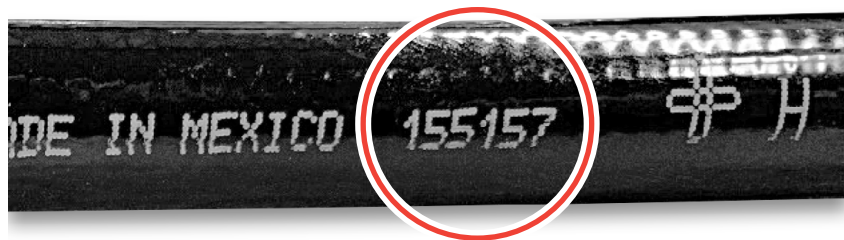
Figure D.

- a. **For hose assemblies:** The lot number is printed on the hose every 12 inches, directly to the right of the "Made in Mexico" label. See figure D. If it is one of the numbers listed below, proceed to Item 5.

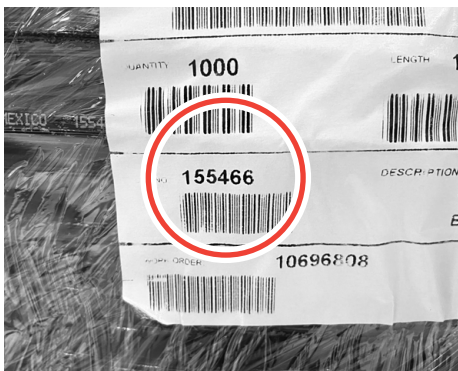
Figure E.

- b. **For bulk hose (1000' reels):** The lot number is printed on the outside of the label as shown in figure E. Note that reels may include up to three different lots, however only one lot number will be printed on the label. If it is one of the lot numbers listed below, proceed to Item 5.
- c. If the lot number is not listed below, **no further action is required.**
