# HYDRAULIC STEERING BLEEDER NUT DEFECTS

Through in house testing, Teleflex Marine has found an isolated failure of Bleeder Nut part # 794926, where it has cracked due to stress corrosion. All Bleeder Nuts that have been assembled with SeaStar or BayStar Cylinders, SeaStar Power Assist Pumps or supplied in SeaStar/BayStar/Hynautic Fitting kits between **March 1st, 2007 and June 30th, 2007** **MUST** be replaced prior to the next use of the vessel. Although very few of these Bleeder Nuts may have been shipped, and the likelihood of a nut cracking during use is extremely remote, Teleflex Marine feels it is prudent to replace ALL Bleeder Nuts immediately.

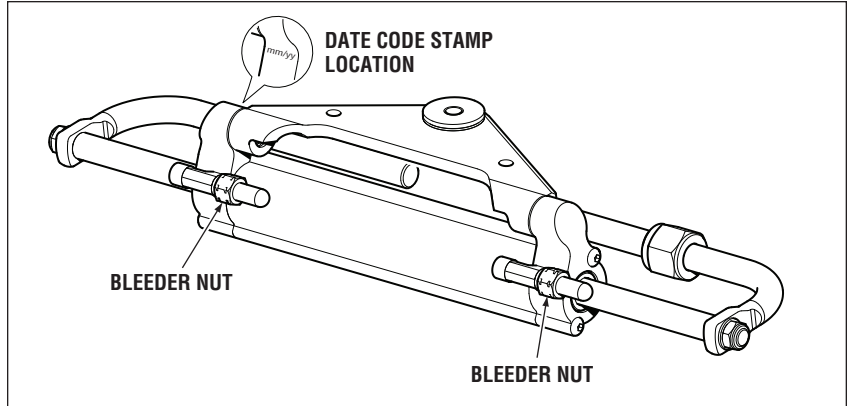
**Figure C: BayStar Steering Cylinder**

The following figures show the location of the “BLEEDER NUT” in relation to the unit it is installed on. We would like to stress that although similar in appearance, the “TUBE NUT” used to crimp SeaStar and BayStar Nylon Tubing onto a helm and/or cylinder (refer to Figure 1c), is NOT affected. To avoid unnecessary time and labor, ENSURE that ONLY the Bleeder Nut is replaced. Page 3 of this Advisory Notice has a complete list of all affected part numbers.

The following figures also show the location of the cylinder Date Code, or on the Power Assist the Serial Number. If the cylinder or Power Assist pump does NOT fall within the date code or serial number noted, there is no need to replace these Bleeder Nuts.

After confirming that the cylinder(s), Power Assist pump(s) and/or Fitting kits fall within the date code and/or serial numbers noted and has bleed nuts **WITHOUT** "Head Markings" as shown on page 1, contact Teleflex Marine at the number listed below to arrange for immediate shipment of new Bleeder Nuts directly to you. Once the new Bleeder Nuts are received there will be no need to return the defective nuts to us. The defective bleeder nuts must be scrapped to prevent these from being used in any other application
