INSTALLATION INSTRUCTIONS

Copy Part# 343321, Rev. C, 01/2014

SEAL REPLACEMENT SEASTAR SeaStar ATM, Inboard Steering Cylinders, -3 Models

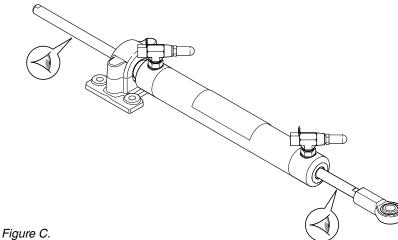
Step 1 Inspect shaft for nicks, dings, scratches, pitting or any other defects. If defects are present, do not replace seals; cylinder must be replaced.

Before attempting to replace these seals check the cylinder shaft surface for any signs of damage, such as; scratches, burrs, dents, dings or pitting. If there is any damage to the shaft the steering cylinder will need to be replaced completely. Installing seals into a cylinder with a damaged cylinder shaft will result in a leak.

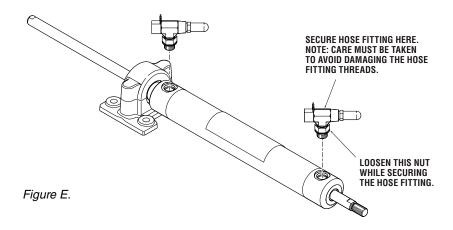
Step 3 While securing hose fitting with a 5/8" open wrench, loosen the 5/8" hose fitting nut and remove the fitting from the cylinder body.

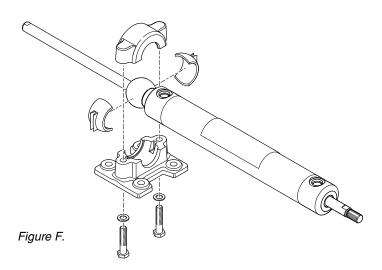
Step 4 Remove the Trunnion Mounting Foot by clamping the cylinder in a soft jawed vice and using a 1/2" socket.

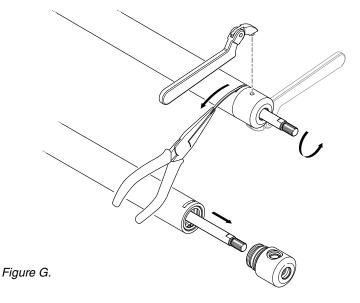
Step 5 Remove the retaining rings that secure both end glands as outlined below.

- Using the spanner wrench, turn end gland 'counter-clockwise' until the retaining ring end becomes visible in the retaining ring slot.
- Using a small, flat head screwdriver, pry up slightly on the end of the retaining wire to provide an area to grab with needle nose pliers.
- Grab onto retaining wire with needle nose pliers.
- Using spanner wrench, turn end gland 'counter-clockwise' pulling the retaining wire out with the pliers.
- Once the retaining wire is removed tap the opposite side of the cylinder shaft using a non-marring hammer. Tap the shaft until the gland releases from the cylinder body.

If the retaining ring does not become visible in the fitting port of the cylinder barrel, it may have broken off inside the cylinder. The only way to remove the broken retaining ring at this point is to tap a second retaining ring in behind the first, forcing the broken ring to be ejected.
